# Dugualla Bay

Dugualla Bay is located on the northeast side of Whidbey Island within the western portion of Skagit Bay. Upstream of the bay, Dugualla Lake was historically a large estuary and salt marsh system that was connected to Dugualla Bay. To create agricultural land, a dike and tide gate system was constructed at the inlet to Dugualla Lake around 1918. This eliminated tidal inundation into the lake and changed Dugualla Lake into a freshwater lake and marsh. Today, a pumping system controls water levels in the lake in order to limit waterfowl use, which poses a risk to low-flying jets approaching Whidbey Naval Air Station (NAS) Ault Field. The restoration would return tidal inundation to Dugualla Lake and restore the historic saltwater marsh and tidal channels. It would also create intertidal mudflats in Dugualla Bay to support eelgrass, herring, and juvenile salmon habitat in Skagit Bay.

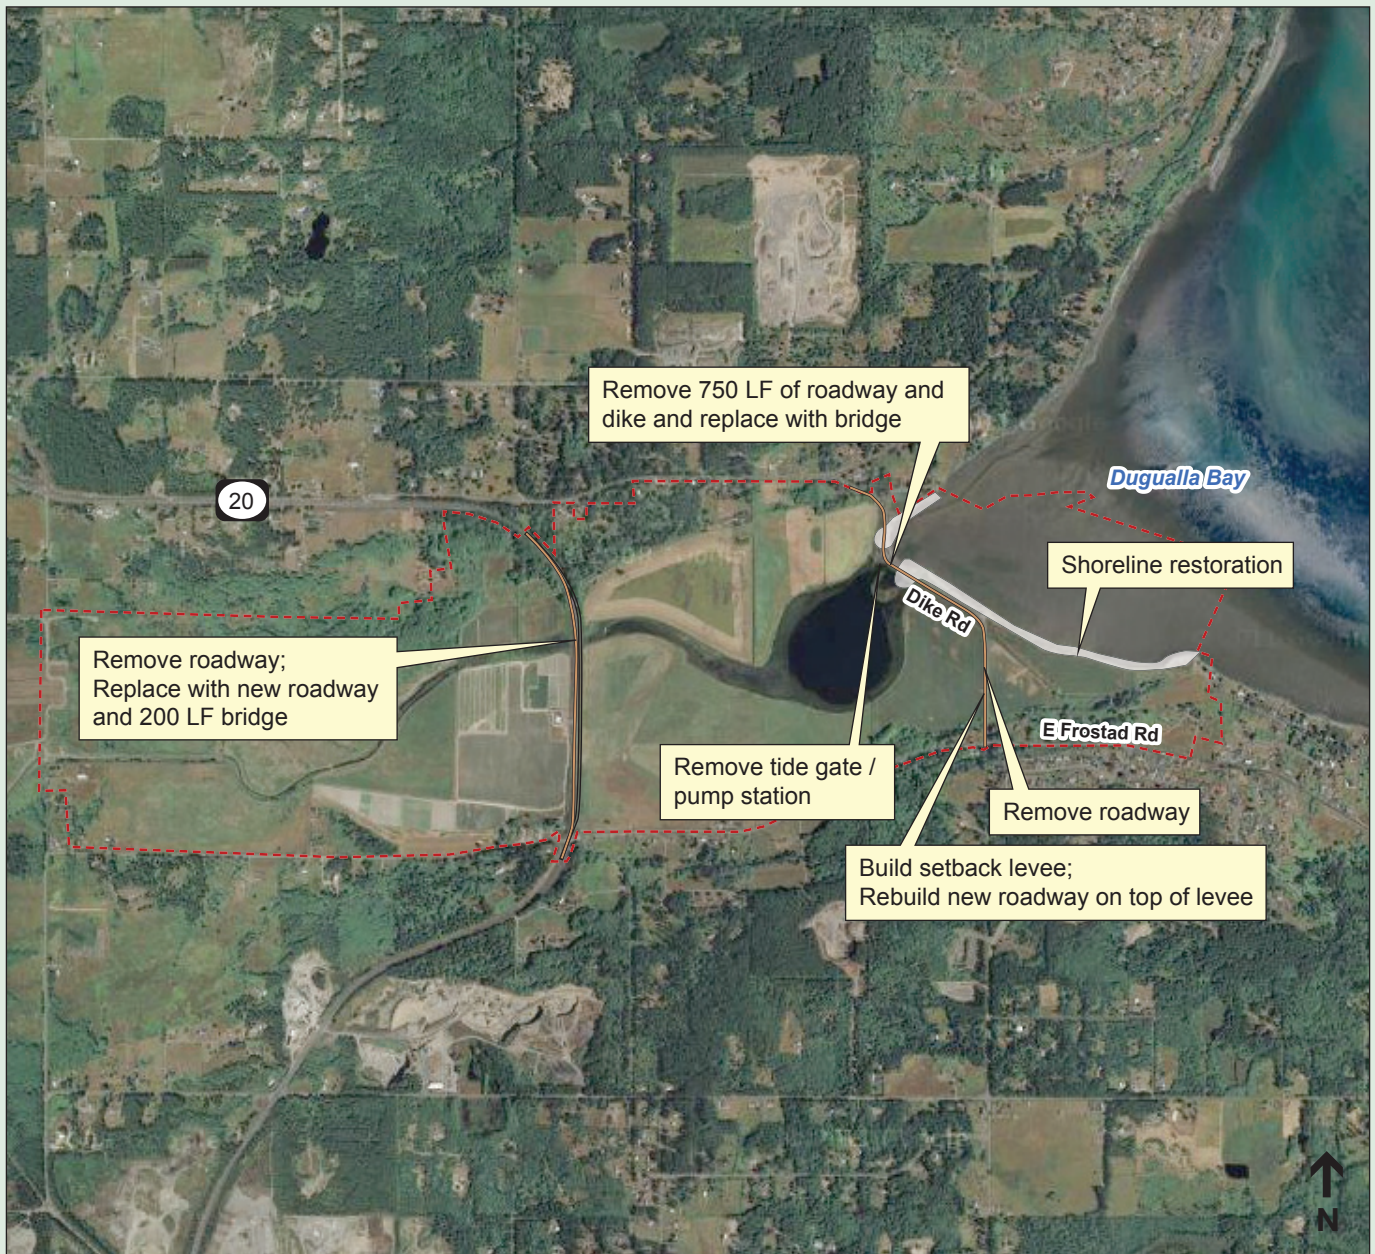
SOURCE: ESA (2011); USDA-NAIP (2009)

Image above depicts major project features. See design report for additional details.

The restoration would return historic tidal inundation to Dugualla Bay through the partial removal of Dike Road between Frostad Road and Frost Lane. The tide gate and pumping system would be removed and a starter channel would be excavated to allow tidal flow into the lake. Two barrier beaches that historically defined the tidal channel entrance would be created. A 750-foot-long bridge would span the opening, allowing continued vehicle passage along Dike Road. Portions of the road would be raised to elevate the roadway out of the newly inundated floodplain. A culvert under State Route 20 would be replaced with a 200-foot-long bridge. Private property and agricultural lands around Dugualla Lake and west of State Route 20 would be purchased.
