# Livingston Bay

Livingston Bay is at the head of extensive mudflats on Camano Island and adjacent to the biologically productive Port Susan Bay. Prior to 1880, the entire estuary was converted from salt marsh behind a sand and pebble beach to agricultural use by the construction of dikes and drainage channels. The restoration would acquire farmland properties and re-establish tidal inundation to 250 acres by excavating a large channel where it was historically located. A tidal channel network would be established within the site and drainage ditches would be filled. A new flood protection dike would be constructed to prevent inundation of the Livingston Bay Community at the east end of the bay.

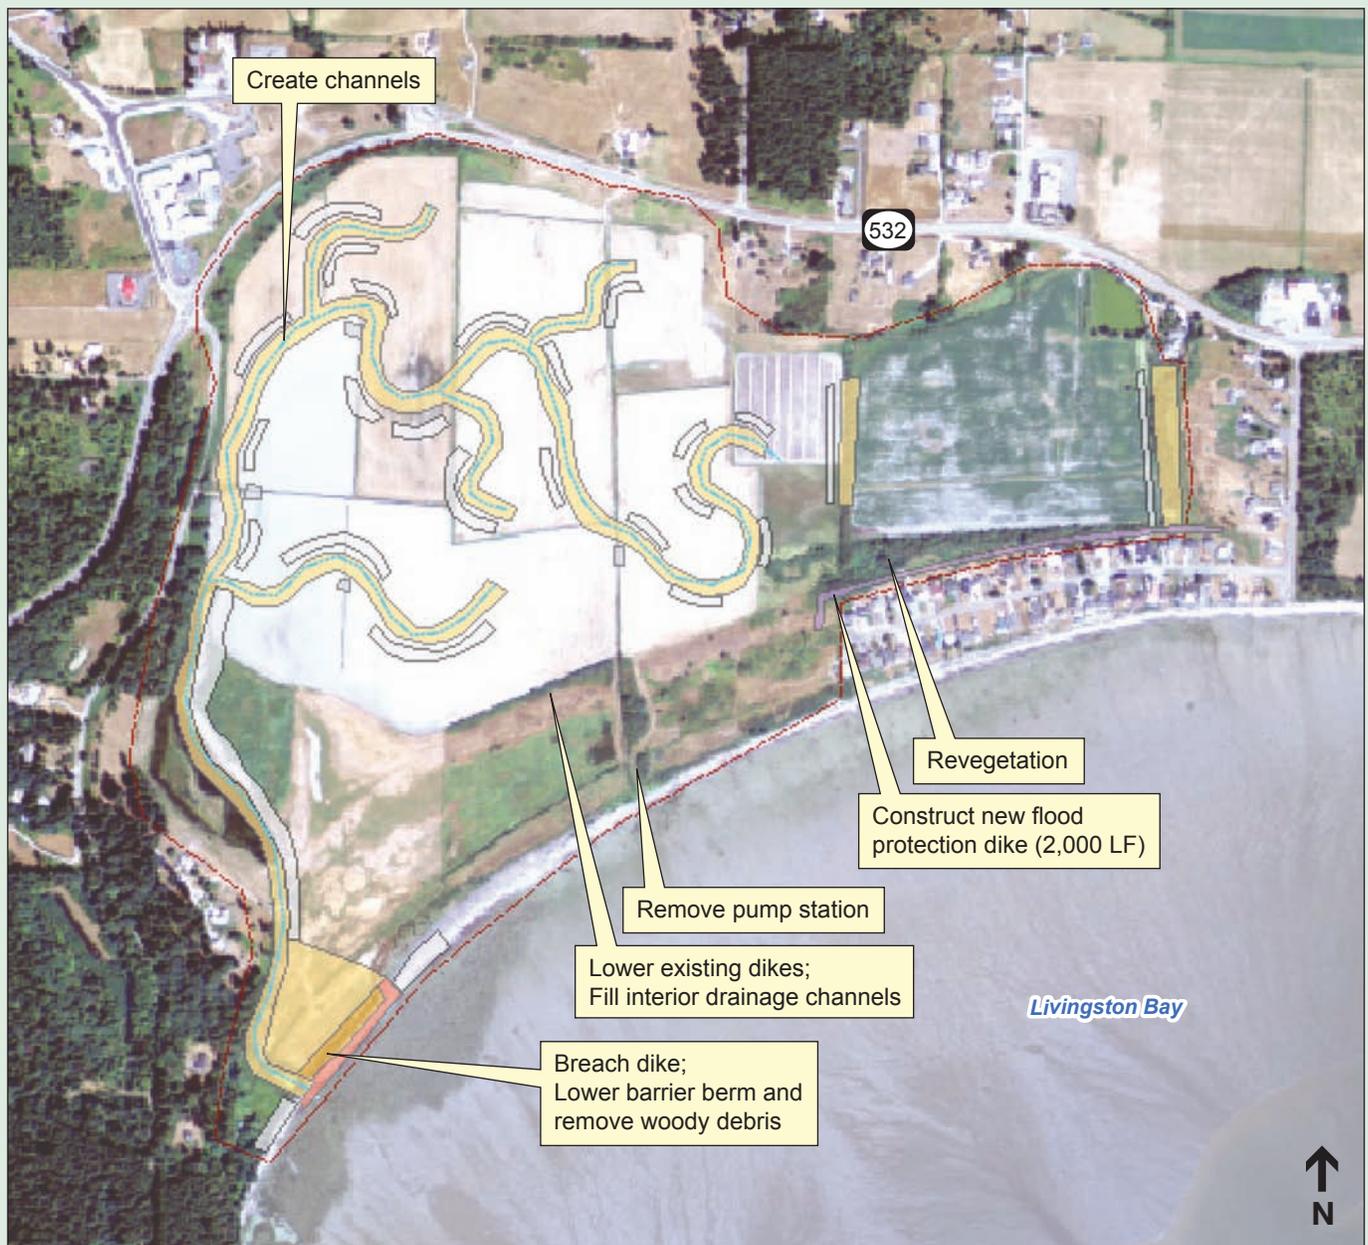
Image above depicts major project features. See design report for additional details.

The restoration would create an opening in the beach at the western end of the bay. A network of starter channels would be excavated to initiate tidal marsh development. Internal drainage ditches would be filled and internal dikes would be lowered. The pump station and associated power poles and lines would be removed. A new flood protection dike would be constructed along the north side of East Livingston Bay Shore Drive to prevent inundation of the Livingston Bay Community. The dike slopes would be planted with riparian vegetation.
